INDOOR AIR QUALITY ASSESSMENT

**Hadley Elementary School
24 Redington Street
Swampscott, Massachusetts**

Prepared by:
Massachusetts Department of Public Health
Bureau of Environmental Health Assessment
April, 2002

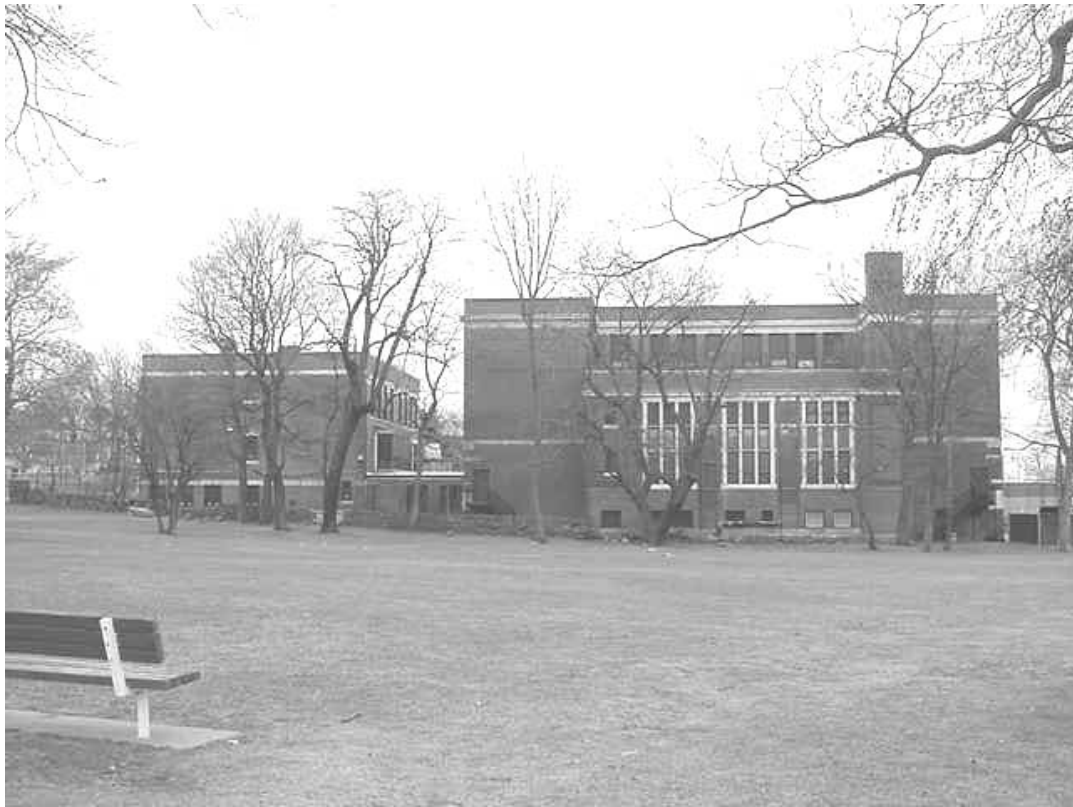
Picture 1

The school is a three-story red brick building with basement constructed in 1911. A three-story annex was added in 1915 connected to the original building by an enclosed corridor (see Picture 1). The 1911 building contains general classrooms, computer room, library, teachers lounge, gymnasium/auditorium, main office and nurse's station and a combination art/music room. The annex contains general classrooms, kindergarten, occupational therapy room, cafeteria and offices.

Hadley Elementary School 1911 and Smaller Annex Building 1915
